INVENTORY SURVEY OF SOME GULLY EROSION SITES IN CENTRAL CROSS RIVER STATE, NIGERIA

Abstract

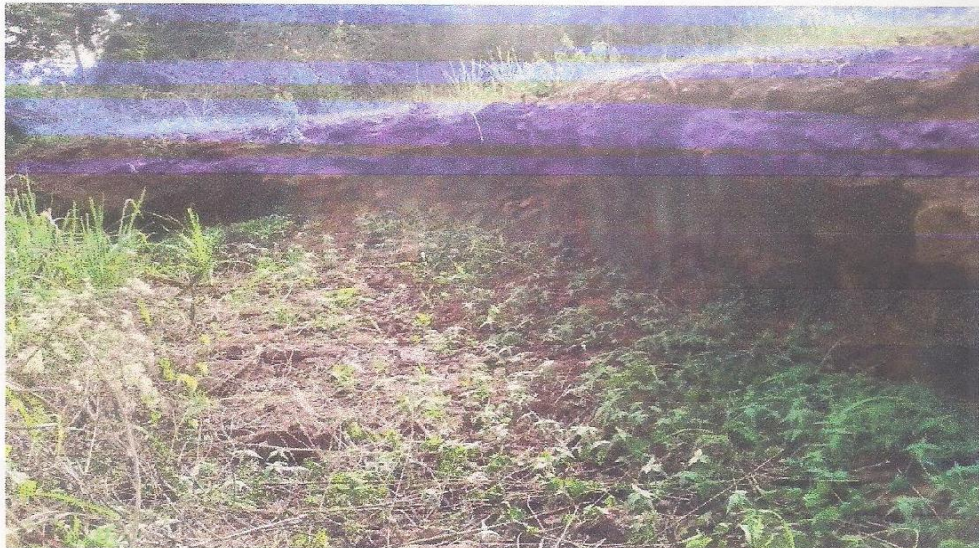
Plate 2: Nnukpein in Apiapum

- (ii) **Nnukpein:** This site is located in Apiapum along the Ikom-Calabar Highway, Opposite Okosisi bus stop. The site had a gully length of 22m, a width of 8m and a depth of 2m. It was suspected to have occurred from uncontrolled run-off from the highway.

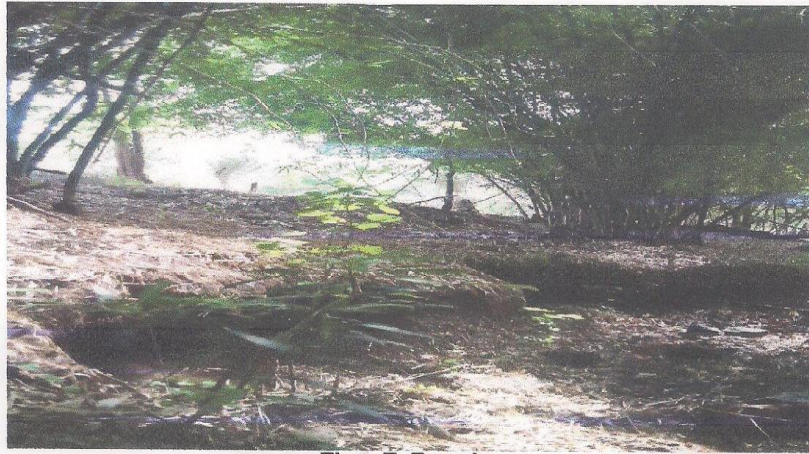
Plate 5: Onyadama

- (v) **Onyadama:** The area is located at Onyadama opposite Saint Patrick Catholic Church. The land use affected was a farmland. The topography of the area was slightly undulating. It had a length of 12m long, 1m wide and a depth of 1m. Land use affected was a pathway.

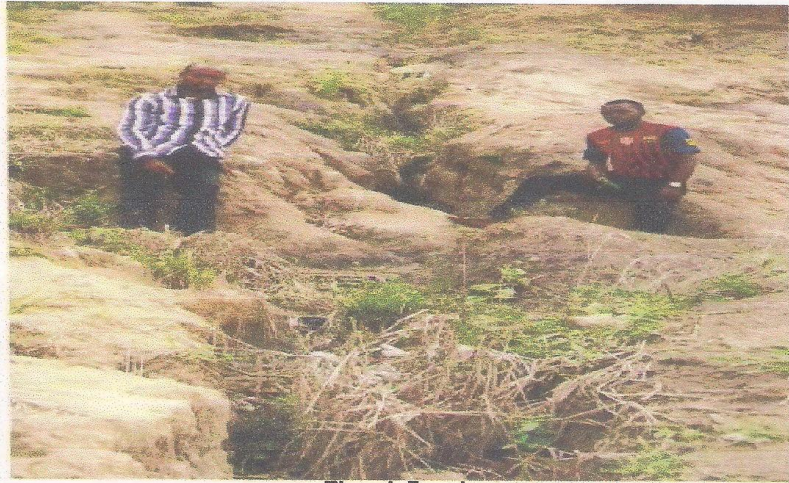
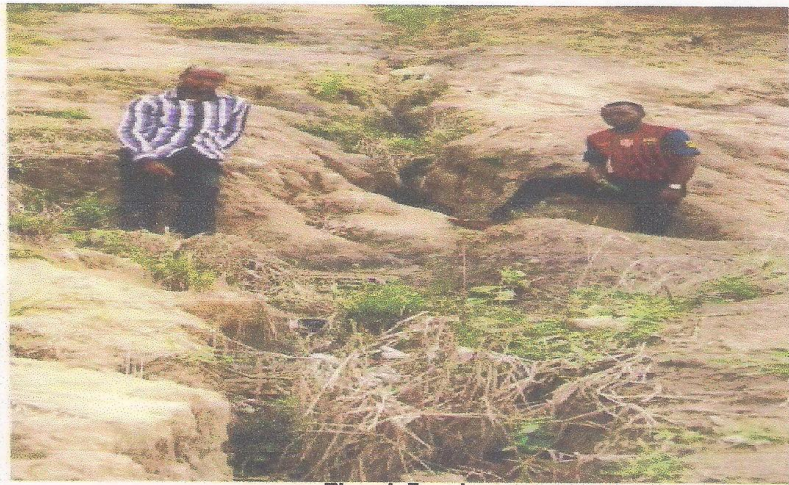
Plate 1: Enoghi

(i) **Enoghi:** This area was observed to have scanty vegetation cover with sloppy land close to a farm land. It has the dimensions of 26m long, 1m wide and a depth of 1m and showed the longest gully length within the Ikom local government area.

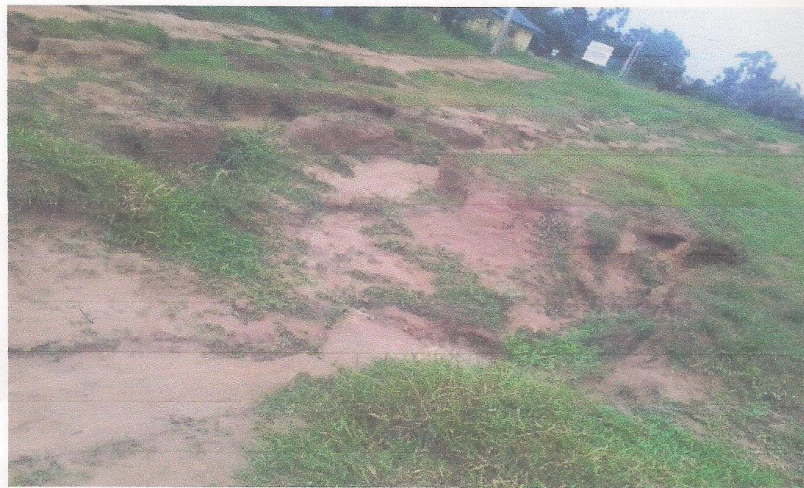
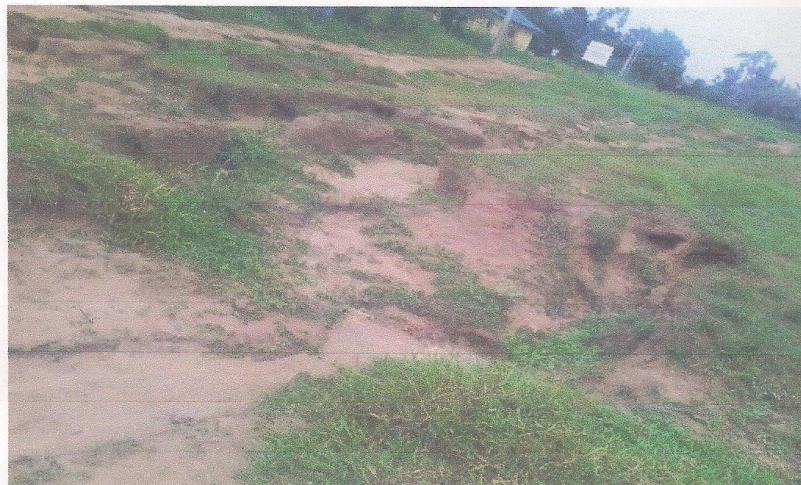
Plate 2: Ekpokpa

- (ii) **Ekpokpa:** The gully is located along Ikom – Ogoja Highway, few kilometers away from Ekereson Filling Station, it has a gully length of 8m, a width of 2m and a depth of 1m. the land use affected was a pathway leading to a proposed medical centre and Saint Paul Primary School. The land lacks shrubs and trees.

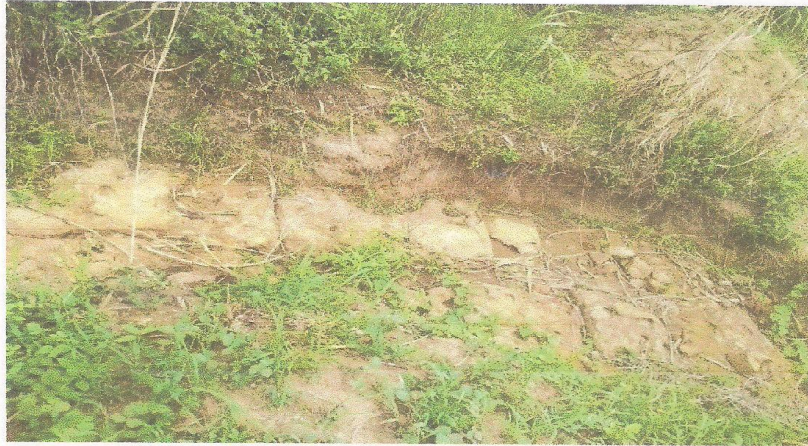
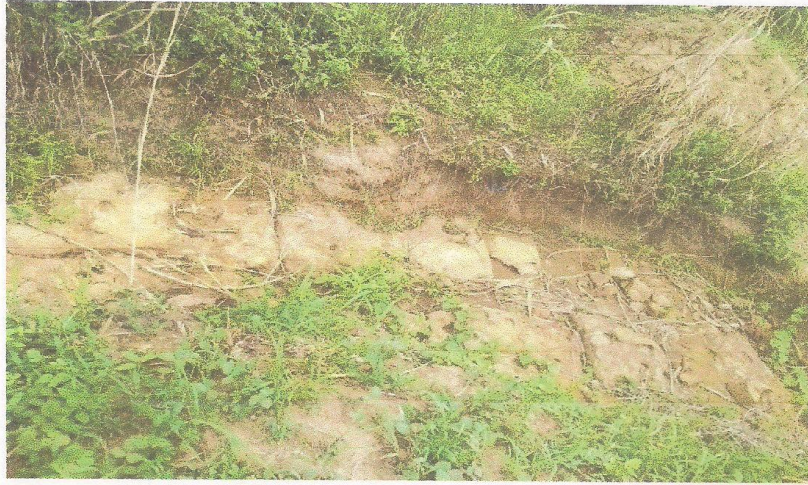
Plate 3: Bokomo village

- (iii) **Bokomo:** This site is located in Bokomo village of Ikom Town (UAC Road) it has a length of 7m, a width of 1m and a depth of 1m. The land use affected is a farm land with less dense vegetation and the soil is made of hard pan.

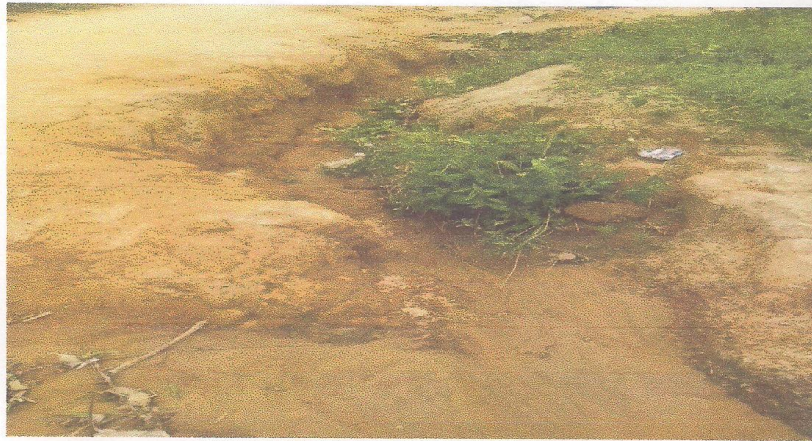
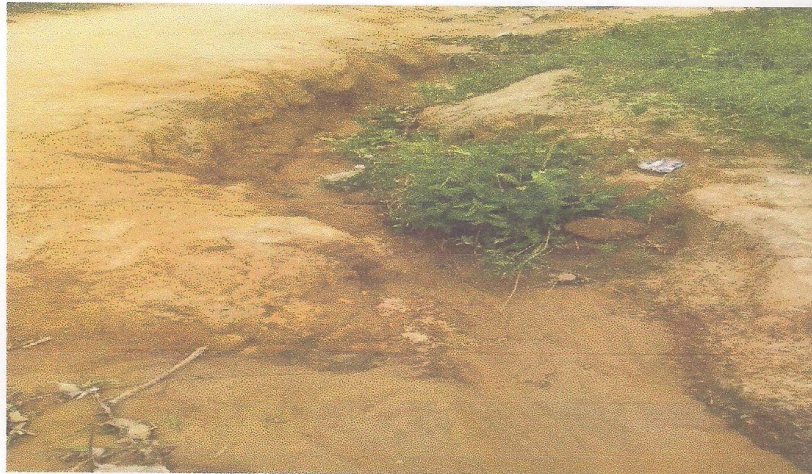
Plate 4: Border Road

- (iv) **Boarder Road:** The fourth site in this area was located at boarder road, the site had a gully length of 10m, a width of 1m and a depth of 2m, it had a sloppy terrain and the area made up of hard pan materials, with the land having no trees on it. This pathway leads to farmland and is usually referred to as farm road by residents in the area.

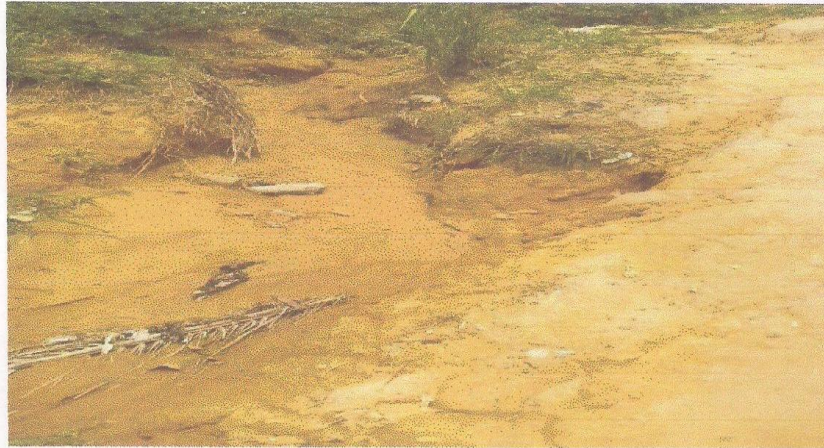
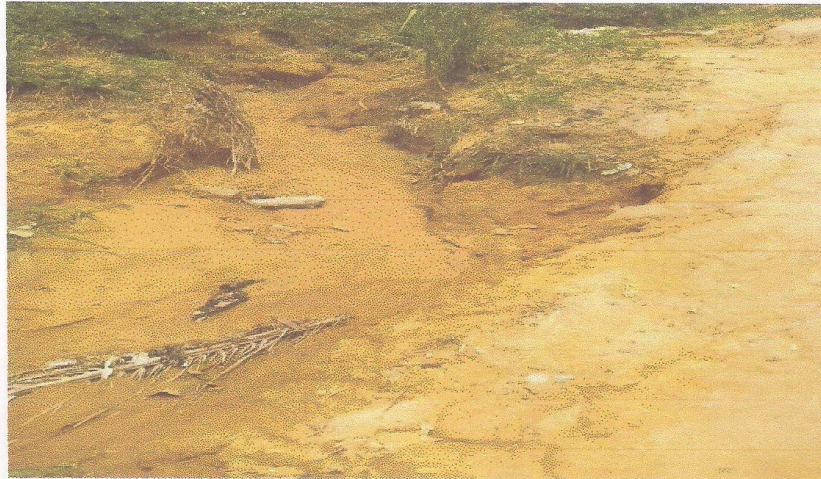
Plate 5: Atimaka

- (v) **Atimaka:** this is located at Atimaka Village along Ogoja Road. The site measured to have a gully length of 9m, a width of 2m and a depth of 1m. it also leads to farmlands.

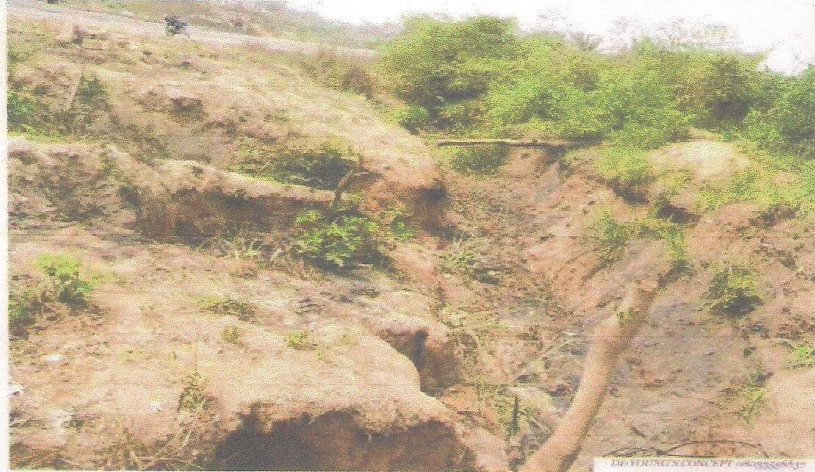
Plate 1: Njelekoko-Ugep

- (i) **Njele Koko:** This site is located in Ugep Town along Ediba Road. The site measuring gully length of 23m, a width of 4.5m and a depth of 2m. The land use affected was pathway.

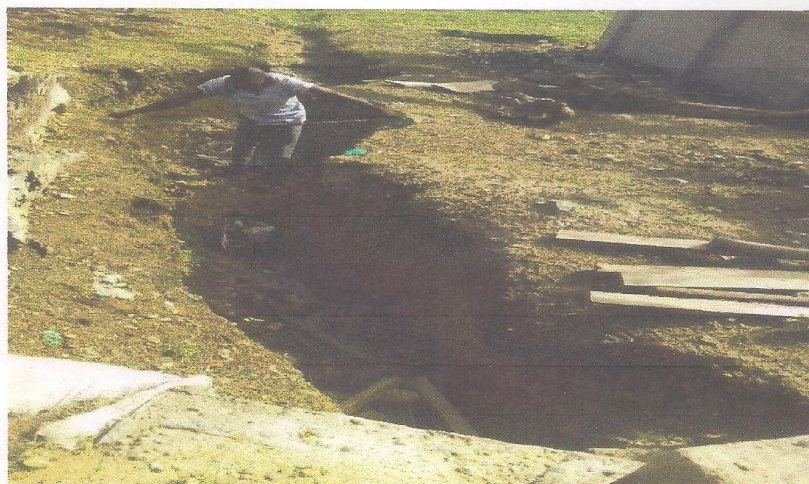
Plate 2: Ajere-Mkpani

- (ii) **Ajere:** This area is located at Yoli-Ajere Mkpani, the land use affected was a residential building and the erosion was suspected to have occur from an uncontrolled run off and had a length of 17m, 1.2m wide and a depth of 1m.

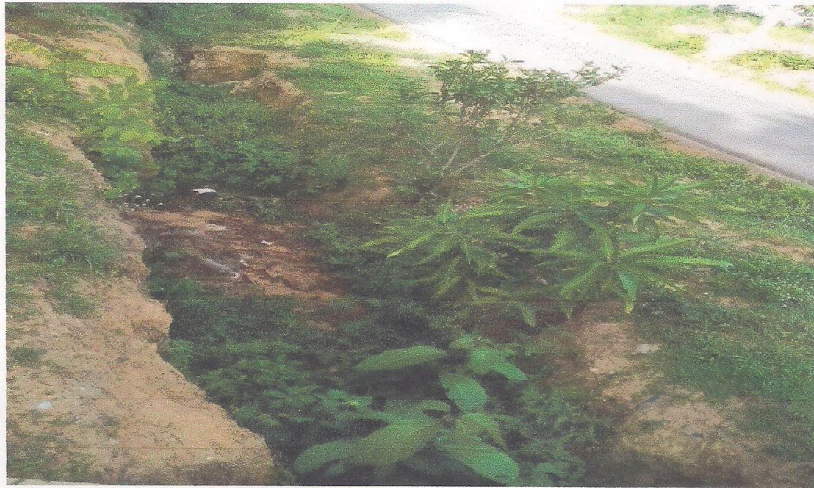
Plate 3: Aduma-Mkpani

- (iii) **Aduma:** This area is located at Lebolkam in Mkpani, it has scanty vegetation and close to the road. It measures 5m in length, 2m in width and a depth of 3m.

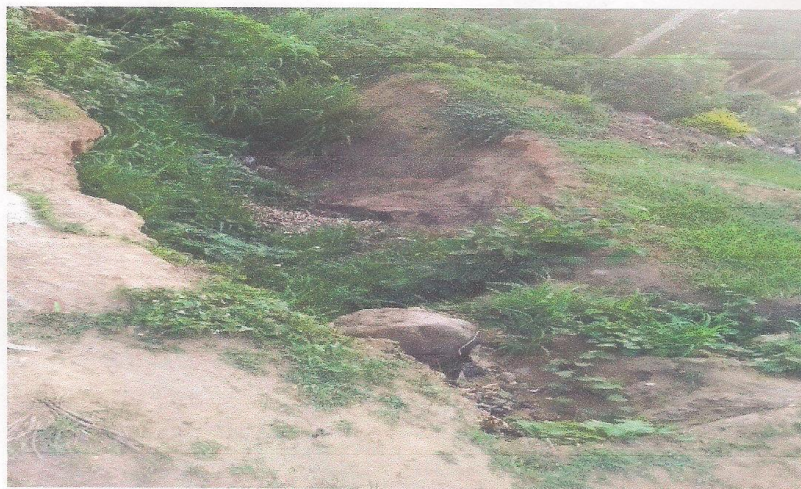
Plate 4: Npoli-Nko

- (iv) **Npoli:** The site is found at Npoli-Okpirike in Nko Town. The land use affected is a pathway, the gully, extends to the right into a farm having numerous trees. It had the measurement of 10m in length, 1m in width and 1m deep. The terrain of the land is sloppy with scatter vegetation cover.

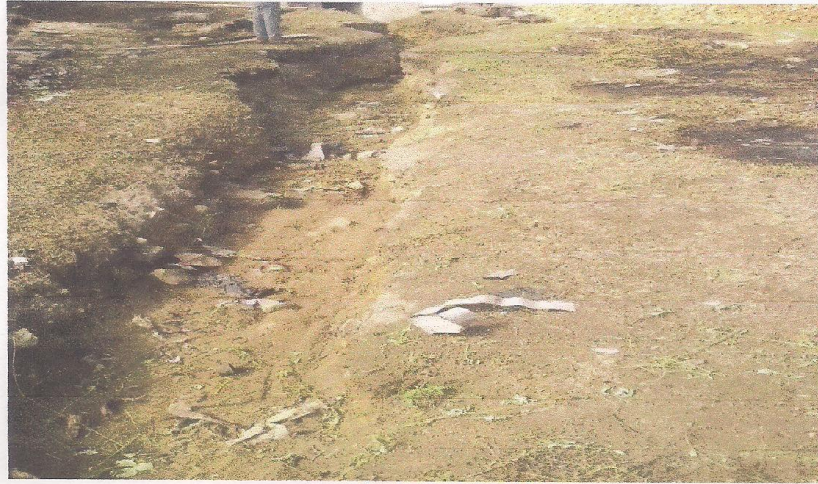
Plate 5: Ofurekpe-Ekori

- (v) **Ofurekpe:** This site is located at Ofurekpe-Kokamplo in Ekori, the land use affected is a pathway close to a residential building. It measures a length of 13m, 2m wide and a depth of 1m.
