Weathering of historical monuments by climate change-A case study of Kaiser Bagh Palace, Lucknow

Seema Singh and Ruchi Saxena* Department of Zoology, Department of Chemistry*
Nari Shiksha Niketan (PG) College, Lucknow

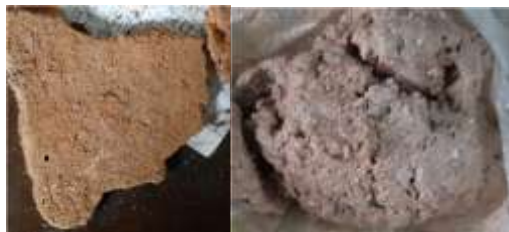
Fig-3 a) weathered lime-stucco collected from Kothi Roshan-ud-Daula b) New plaster prepared for restoration

The research design consisted of the observation method which was a primary survey of the historical monuments/site and samples of lime stuccos were collected for analysis in the lab (Fig-3a, and b). A comparison was drawn with the earlier photographs and literature. The extent of weathering was studied by considering physical, chemical, biological and microbiological factors.

1. 1gm powder of sample **a** and **b** were dissolved in concentrated HCl.

Result: the sample **b** dissolved in HCl by the evolution of CO₂ indicating the presence of lime. The residues was washed with H₂O which dissolved partly in ethanol and chloroform indicating that the chunam contained organic material.

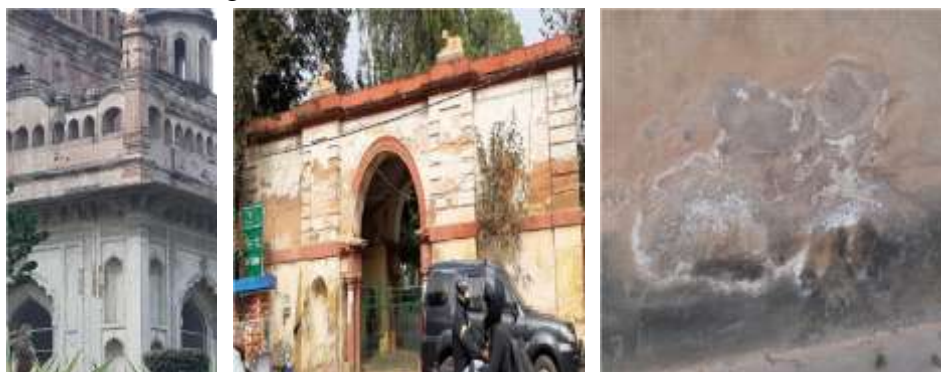
Fig. 4 a) Makbara Saadat Ali Khan; black crust and flaking of plaster exposing lakhauri bricks b) Neil's Gate; visible colour change, loss of plaster as powder c) Tomb of Mushir Zadi; *Flostectorii* degradation by Actinobacteria

Lucknow's Neil Gate (Sher Darwaja) was a Gateway to Kaiser Bagh, constructed 150 years ago, and situated at the southern end of the present Globe Park. It has a pair of tigers seated on its top and was painted white and red. The upper part of the gate is missing due to weathering (Fig-4b).

Located opposite Begum Hazrat Mahal Park, the tomb (*Makbara*) was built by the King Ghaziud-din Haider (1817-1827). It has five octagonal *chhatris* with the central one being the biggest and fluted and octagonal marble floor in a chessboard pattern. The main hall has rectangular verandas on two sides and pillared kiosks with domes at the corners. The ceilings within the tomb has intricate motifs. There is a perfunctory tomb in the main hall and the actual one is in the basement. Over grown plants have created cracks in the chunam and exposed the lakhauri bricks (Fig-4a).

Another tomb of Khursheed Zadi was built by Ghazi-ud-din Haider by the side and similar in structure to Saadat Ali Khan's tomb. The underground vault contains two graves (Khursheed Zadi and her daughter). *Flostectorii* degradation by Actinobacteria is visible all around (Fig 4c).

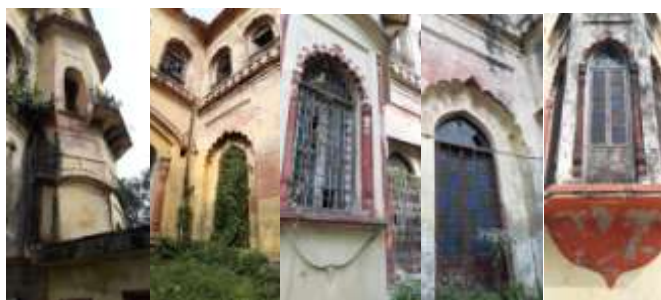
Fig-5. PariKhana: visible change in colour, detachment of parapet, crack formation with plants

Nawabs Wajid Ali Shah built a PariKhana between the tombs and Safed baradari for cultural activities. The central hall of the building was adorned with several chandeliers and has a marble courtyard with ceramic flower pots. Opposite the main building is the garden with lamp posts, marble sculptures and a canal with a marble bridge. Today, the PariKhana houses the Folk Art Museum and Bhatkhande Music University. Severe weathering was observed in PariKhana with change in colour, detachment of parapet, material loss as powdering, granular disintegration, exposure of bricks, deposition of black crust, crack formation with numerous plant species inhabited by fungi, microorganisms and insects (Fig-5).

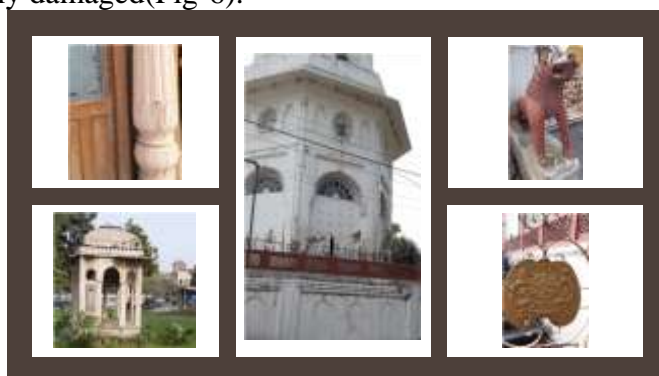
Fig-6 Safed Baradari visibly damaged.

Safed baradari or qasr-ul-aza of Lucknow was built in 1854 by Wajid Ali Shah in white marble on a raised platform or plinth with twelve doors, elaborate corridors, halls with stained glass windows, glass chandeliers and two marble statues. The entrance has octagonal pillars having intricate floral patterns. The hall is now used as a community centre. There was visible material loss as powdering, granular disintegration and deposition of black crust with seepage. The stucco work had been replaced by cement during restoration but has weathered again. The metal emblem and the tiger statue is damaged. Both the marble baradaris in outer gardens are blackened and heavily damaged (Fig-6).

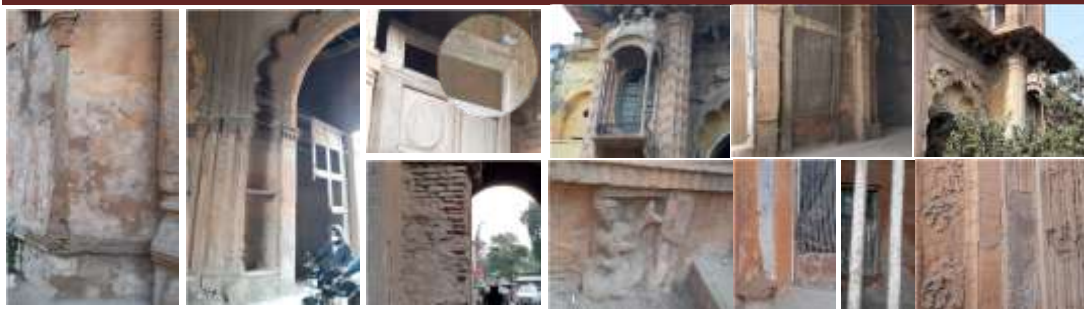
Fig-7 Lakhidarwajas in dilapidated state.

The visible damages in Lakhi Darwaja are: change in colour, crack formation with plants, material loss as powdering, granular disintegration, loss of stuccos, *Florestectori* deposition of black crust on the plasters, growth of fungus and microorganisms, inhabited by insects, pests, rodents and birds etc., the mechanico-biochemical decomposition of the wooden gates, roof, damaged, rusted iron gates (Fig-7).

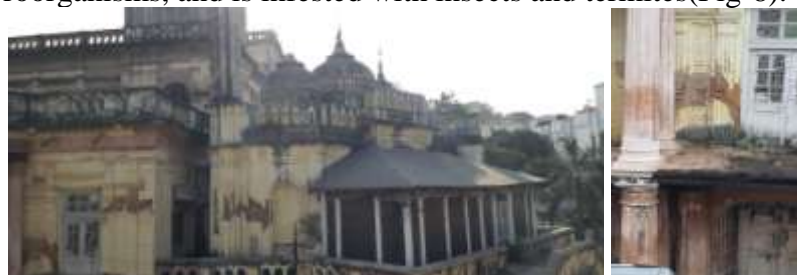
Fig-8 Defaced Kothi Roshan-ud-Daula

The original Kothi was defaced by the demolition of the top floor. Change in colour is obvious with black crust deposition, with detachments as scales and flakes of the chunam, crack formation with plants, material loss as powdering, granular disintegration, development of fungus and microorganisms, and is infested with insects and termites (Fig-8).

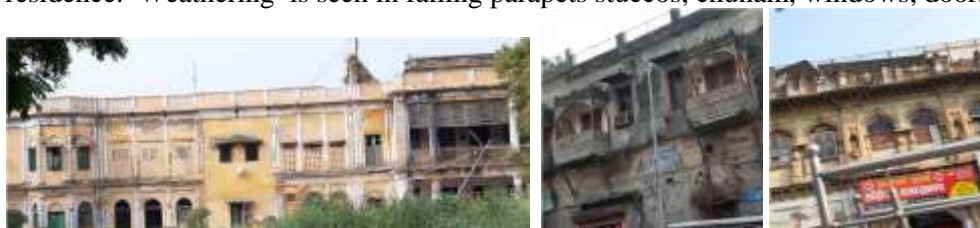
The Chaulakhi Kothi was made by Wajid Ali Shah's barber Azimullah Khan that was later seized by the Nawab and used as a palace. It was mostly destroyed by the British troops and is presently used as residence. Weathering is seen in falling parapets, stuccos, chunam, windows, doors and blinds (Fig-9).

Fig-9 Remains of Chaulakhi Kothi, Kaiser Bagh Circle, Kotwara house. The ambient air quality (AAQ) for the year 2008, 2009 and 2010 as depicted in the figures indicate PM_{10} much above the NAAQ level and NO_2 is almost the same as the threshold limit (Fig-10)
